**Summary of 5.8 magnitude earthquake near Pawnee, Oklahoma
on September 3, 2016,
DamWatch Seismic Alerts, and impact on Watershed dams**

Larry Caldwell P.E.
Watershed Specialist
Oklahoma Conservation Commission

This is a brief summary of the Oklahoma 5.8 earthquake and aftershocks on September 3 and 4, how DamWatch reacted with revised USGS estimates of pga's* through the first day after the earthquake, and the impact on watershed dams near the epicenter.

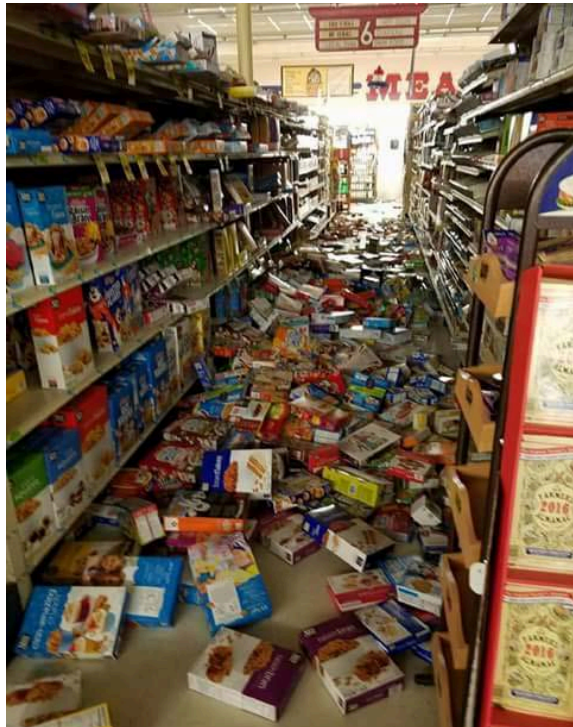
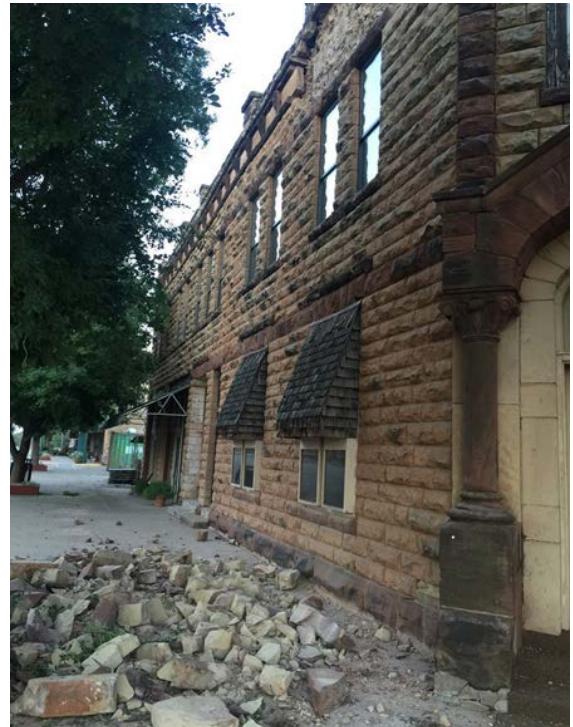
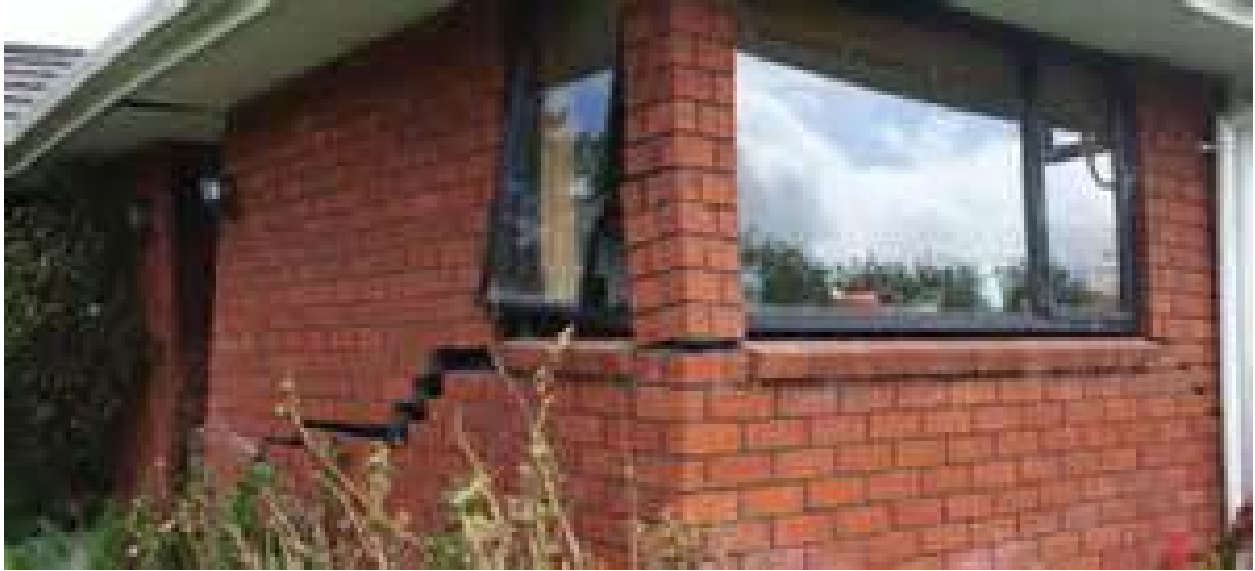
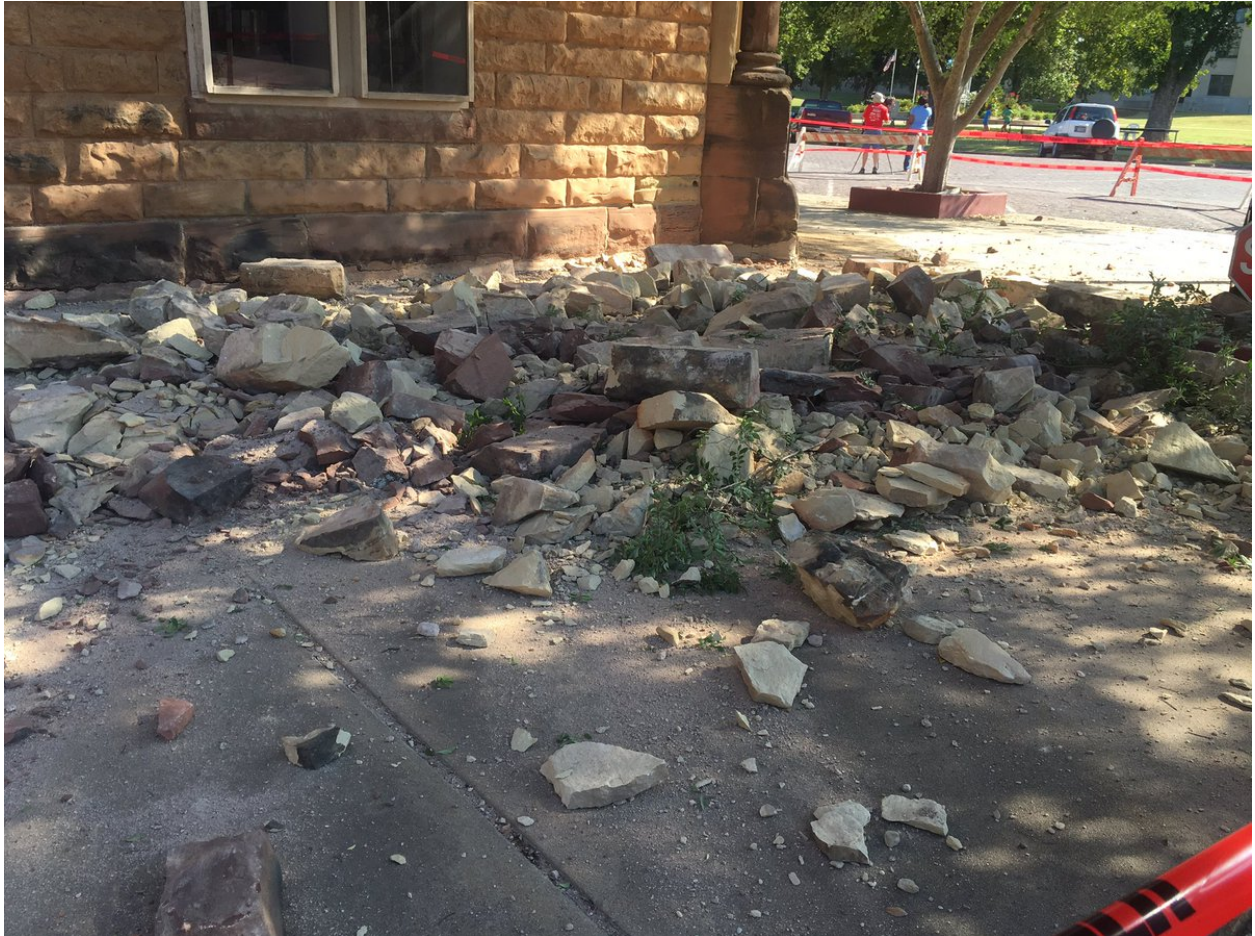
Photos of Damage in Pawnee, Oklahoma; September 3, 2016

Extensive damage was reported to a few buildings in Pawnee and the surrounding area. Only one injury was reported. Damages were generally limited to rock facades falling off buildings, cracks in walls, items falling over shelves, etc., however there was at least one fire due to electrical issues or gas line break. The Oklahoma Geological Survey said that the hard bedrock beneath the surface in north-central Oklahoma is likely the reason for less damage than what would have occurred in other areas of the state with softer subsurface conditions.
