## Magma Flood Retarding Structure Pinal County, Arizona

## Chiwapa Creek Watershed Dam No. 65 Pontotoc County, Mississippi

# Watershed Rehabilitation Progress Report February 2017

## Upper North River Watershed Dam No. 10 Augusta County, Virginia

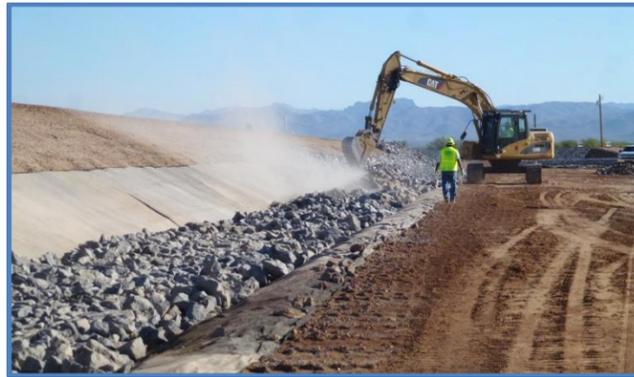
Rip rap rock was placed for erosion protection for the auxiliary as part of the rehabilitation project.

Rehabilitation included raising the top of dam by four feet, construction of a central filter along the length of the embankment, protecting the auxiliary spillway from erosion using rock riprap, and improving the principal spillway outlet with a reinforced concrete dissipation structure and riprap channel. The project was completed in 2016.

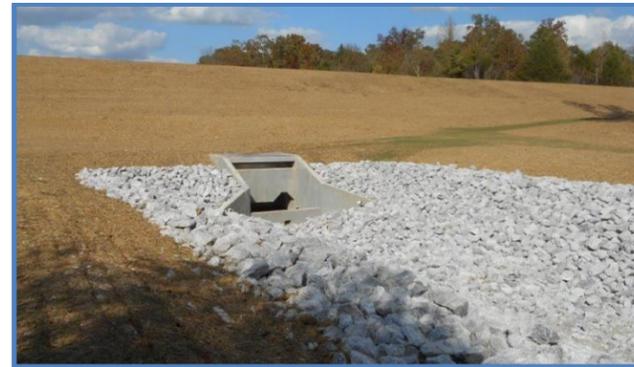
A new outlet channel and impact basin was constructed as part of the rehabilitation project.

A new riser replaced the existing one and a new 30-inch principal spillway pipe was added on to existing 30-inch principal spillway at the outlet end and an impact and basin outlet channel was constructed. The top of dam was raised approximately 6.8 feet, the auxiliary spillway was widened by approximately 82 feet and a chimney drain was added.

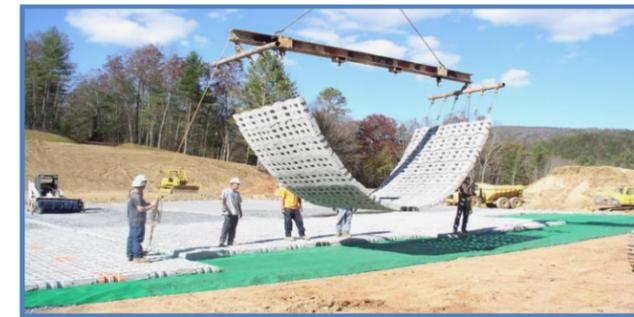
Sections of the auxiliary spillway were covered with articulated concrete blocks to prevent surface erosion.

Rehabilitation included replacement of the 18-inch reinforced concrete principal spillway pipe and inlet tower with a 30-inch diameter reinforced concrete conduit with a standard open-top riser. The top of the dam was raised 1.6 feet. The auxiliary spillway was expanded from 40 feet to 140 feet wide and the spillway crest was raised 1.2 feet.

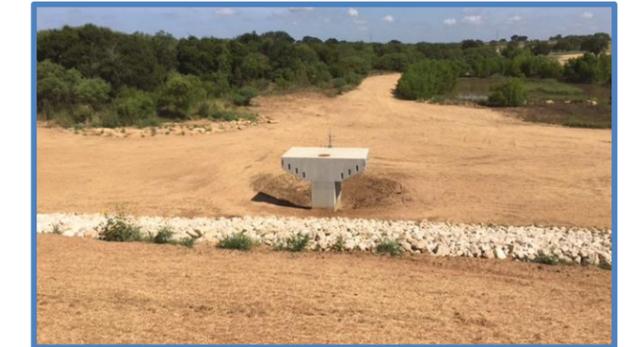
A new concrete inlet tower and a 42-inch diameter reinforced concrete conduit were installed during rehabilitation of the dam.

The rehabilitation project was completed in July 2016. Rehabilitation of the dam brought it up to current State dam safety criteria and extended its life and its benefits for another 50 years.
